Non-Destructive TSV Inspection System SP8000S

SPIROX *LTS*TM
Spirox *L*aser *T*omography *S*can

Non-Destructive: Effective Alternative to SEM Imaging
Industry First: Quantitative Inspection in TSV Process

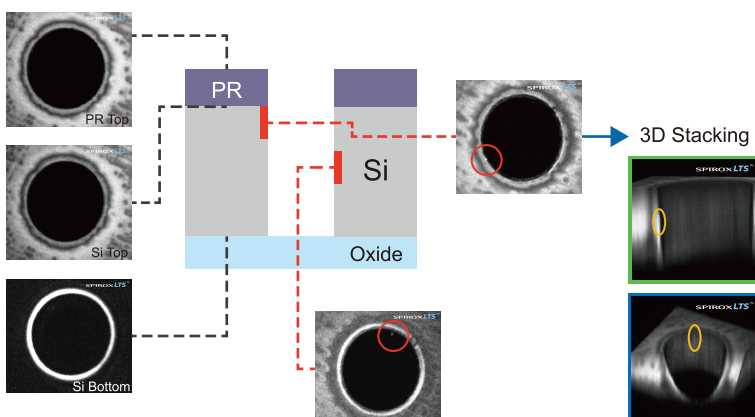
Capturing TSV Striation Cross-Section and 3D Imaging

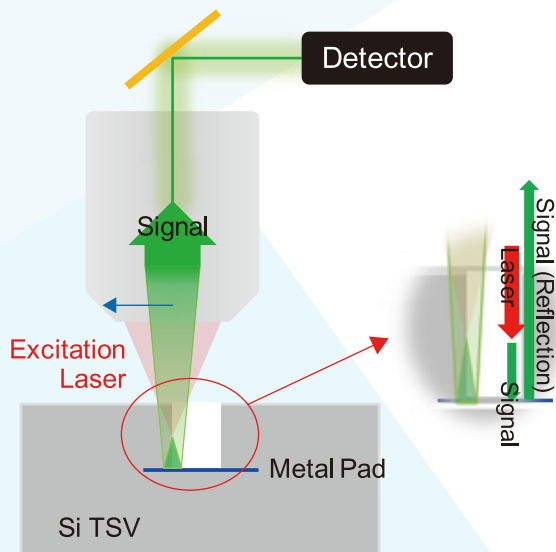
SP8000S

Optical Path Architecture
